3.2.12 Lower Occoquan Group Summary

3.2.12.1 Mill Branch Watershed

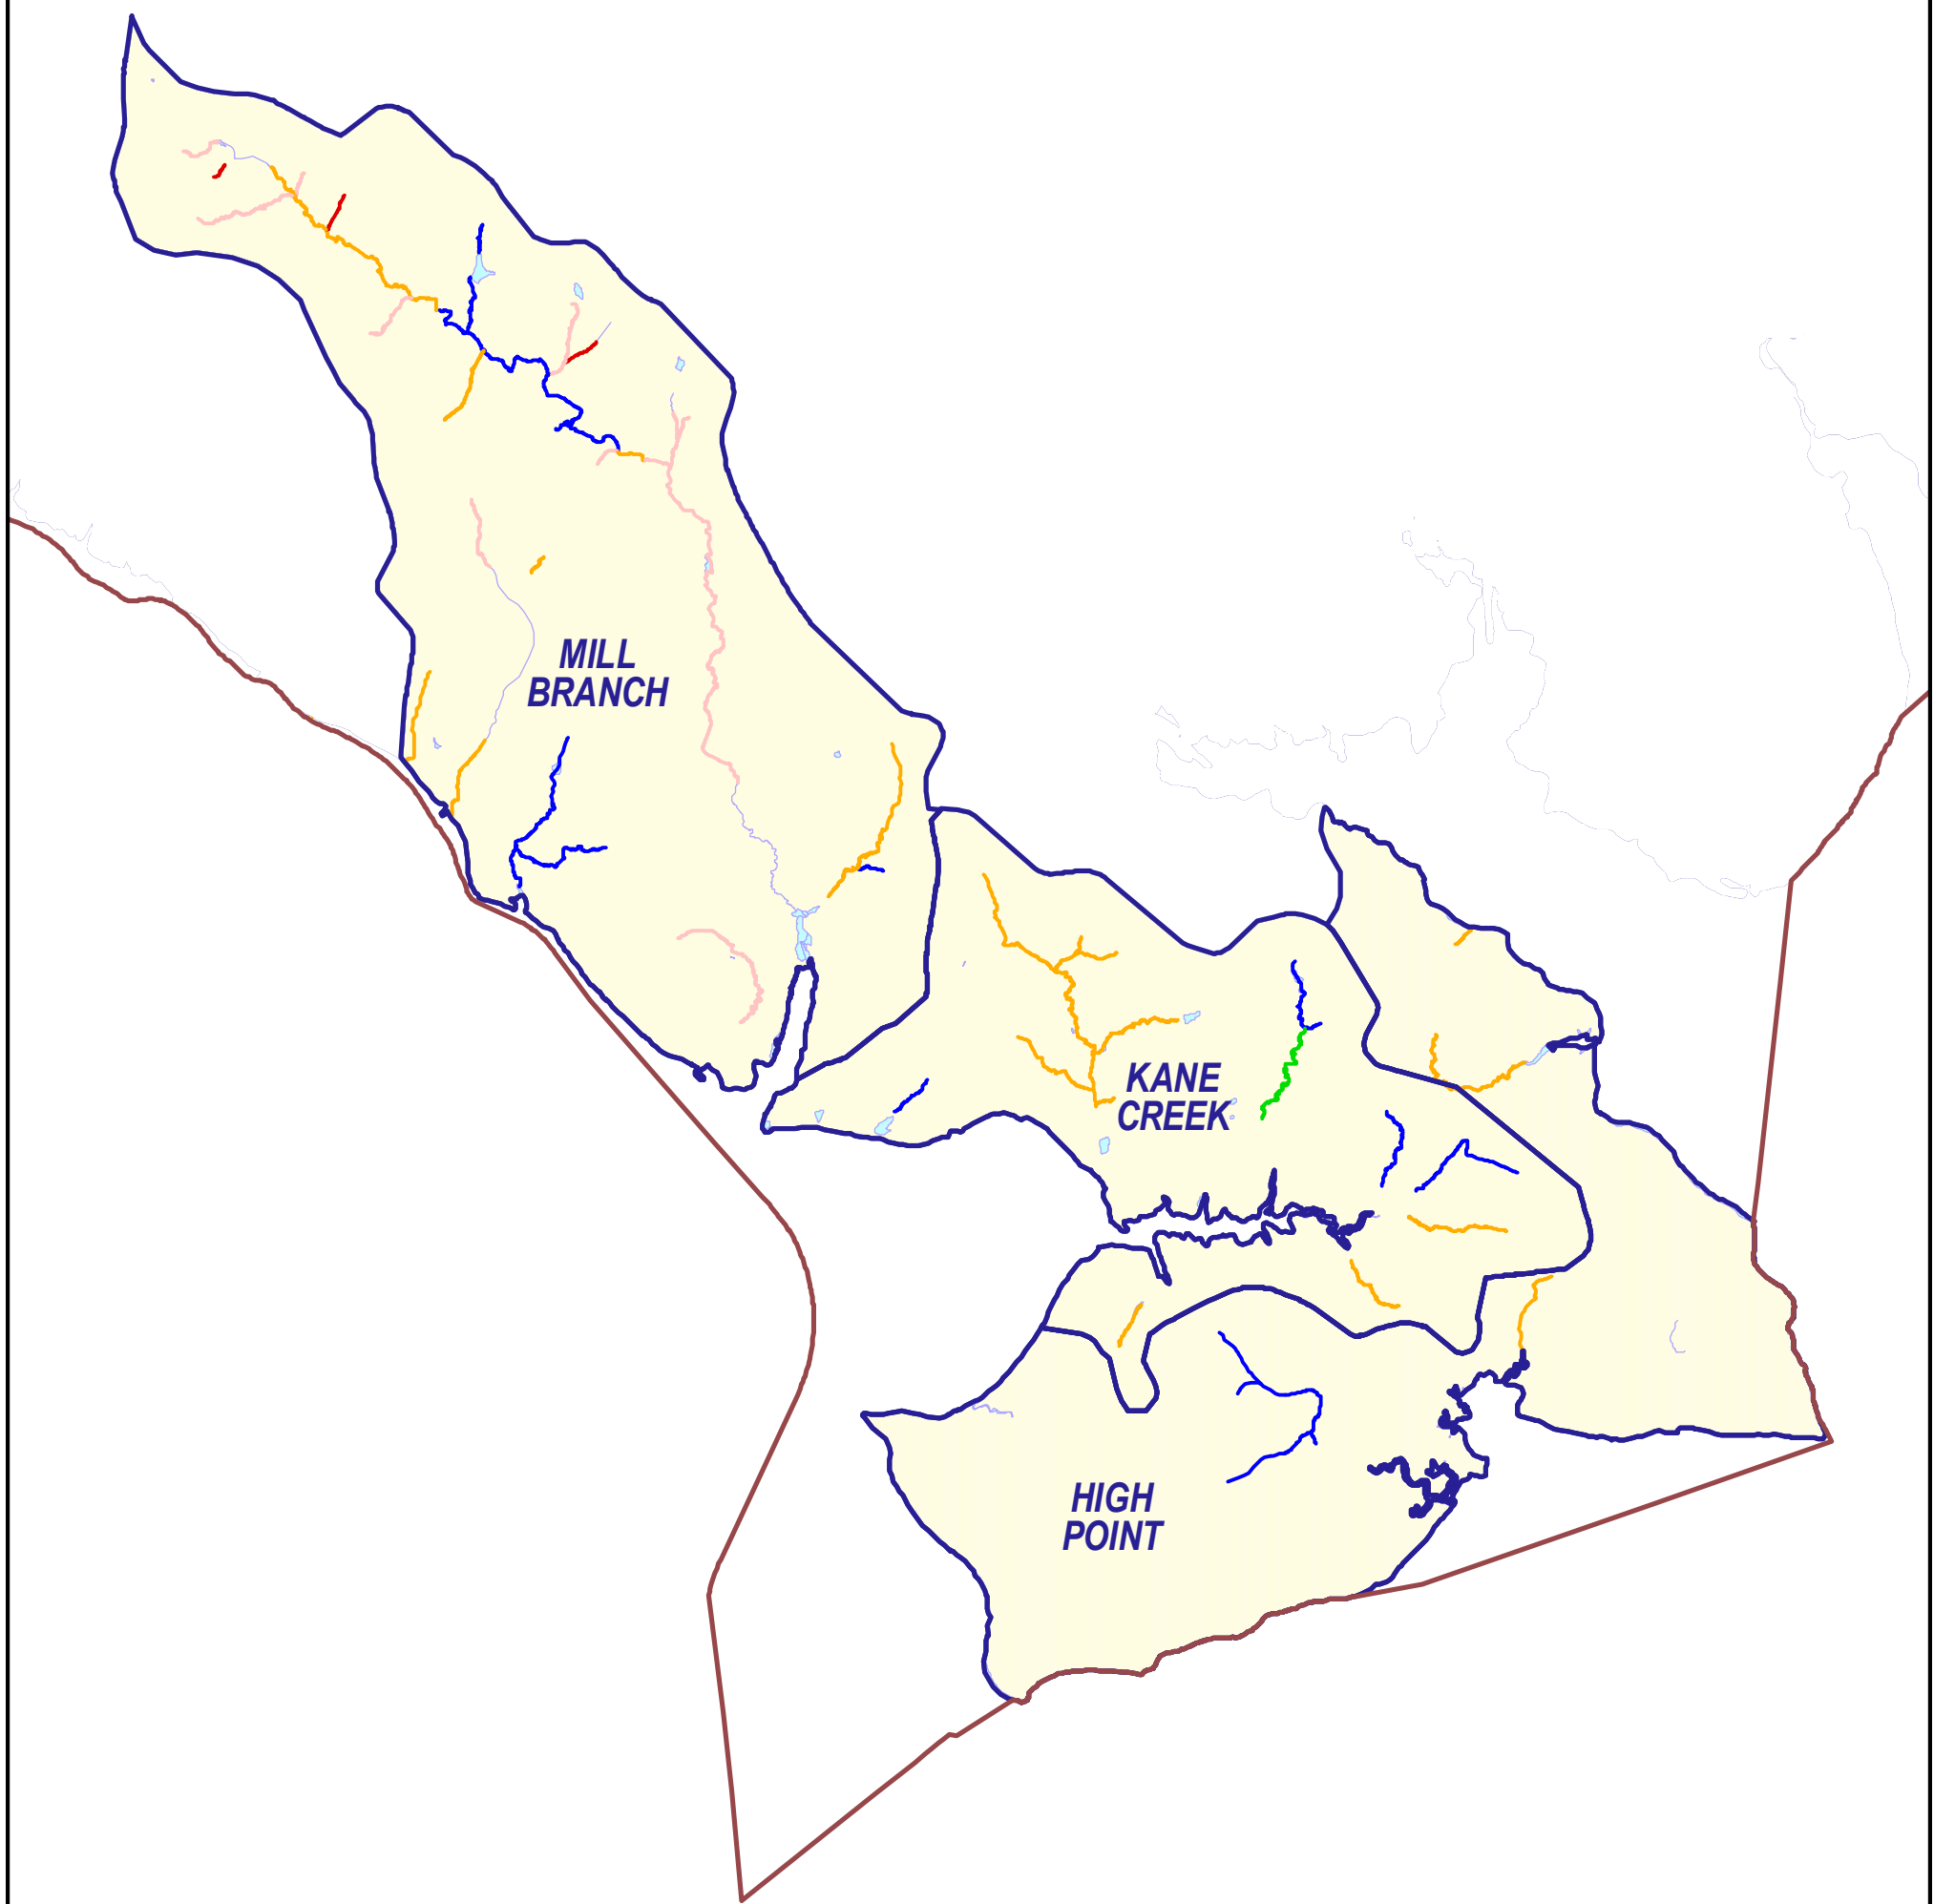
Figure 3-80
Habitat Assessment
Lower Occoquan Group
Fairfax County Stream Physical Assessment

Habitat. The habitat assessment results for Mill Branch Watershed are summarized by stream in Table 3-59. Habitat scores for each reach are depicted in Figure 3-80. Based on a length weighted habitat score of 106 (Table 3-2), Mill Branch Watershed is in the middle range of quality, compared to the rest of the County. Approximately 0.5 mile of stream was categorized as having “very poor” habitat conditions, 6 miles as “poor,” 4 miles as “fair,” and 4 miles as “good.”

Habitat. The habitat assessment results for Kane Creek Watershed are summarized by stream in Table 3-61. Habitat scores for each reach are depicted in Figure 3-80. Based on a length weighted habitat score of 128 (Table 3-2), Kane Creek Watershed is in the upper range of quality, compared to the rest of the County. Approximately 4.5 miles of stream were categorized as having “fair” habitat conditions, 2 miles as “good,” and 1 mile as “excellent.”

Habitat. The habitat assessment results for High Point Watershed are summarized by stream in Table 3-63. Habitat scores for each reach are depicted in Figure 3-80. Based on a length weighted habitat score of 124 (Table 3-2), High Point Watershed is in the upper range of quality, compared to the rest of the County. Approximately 1.5 miles of stream were categorized as having “fair” habitat conditions, and 1.5 miles as “good.”

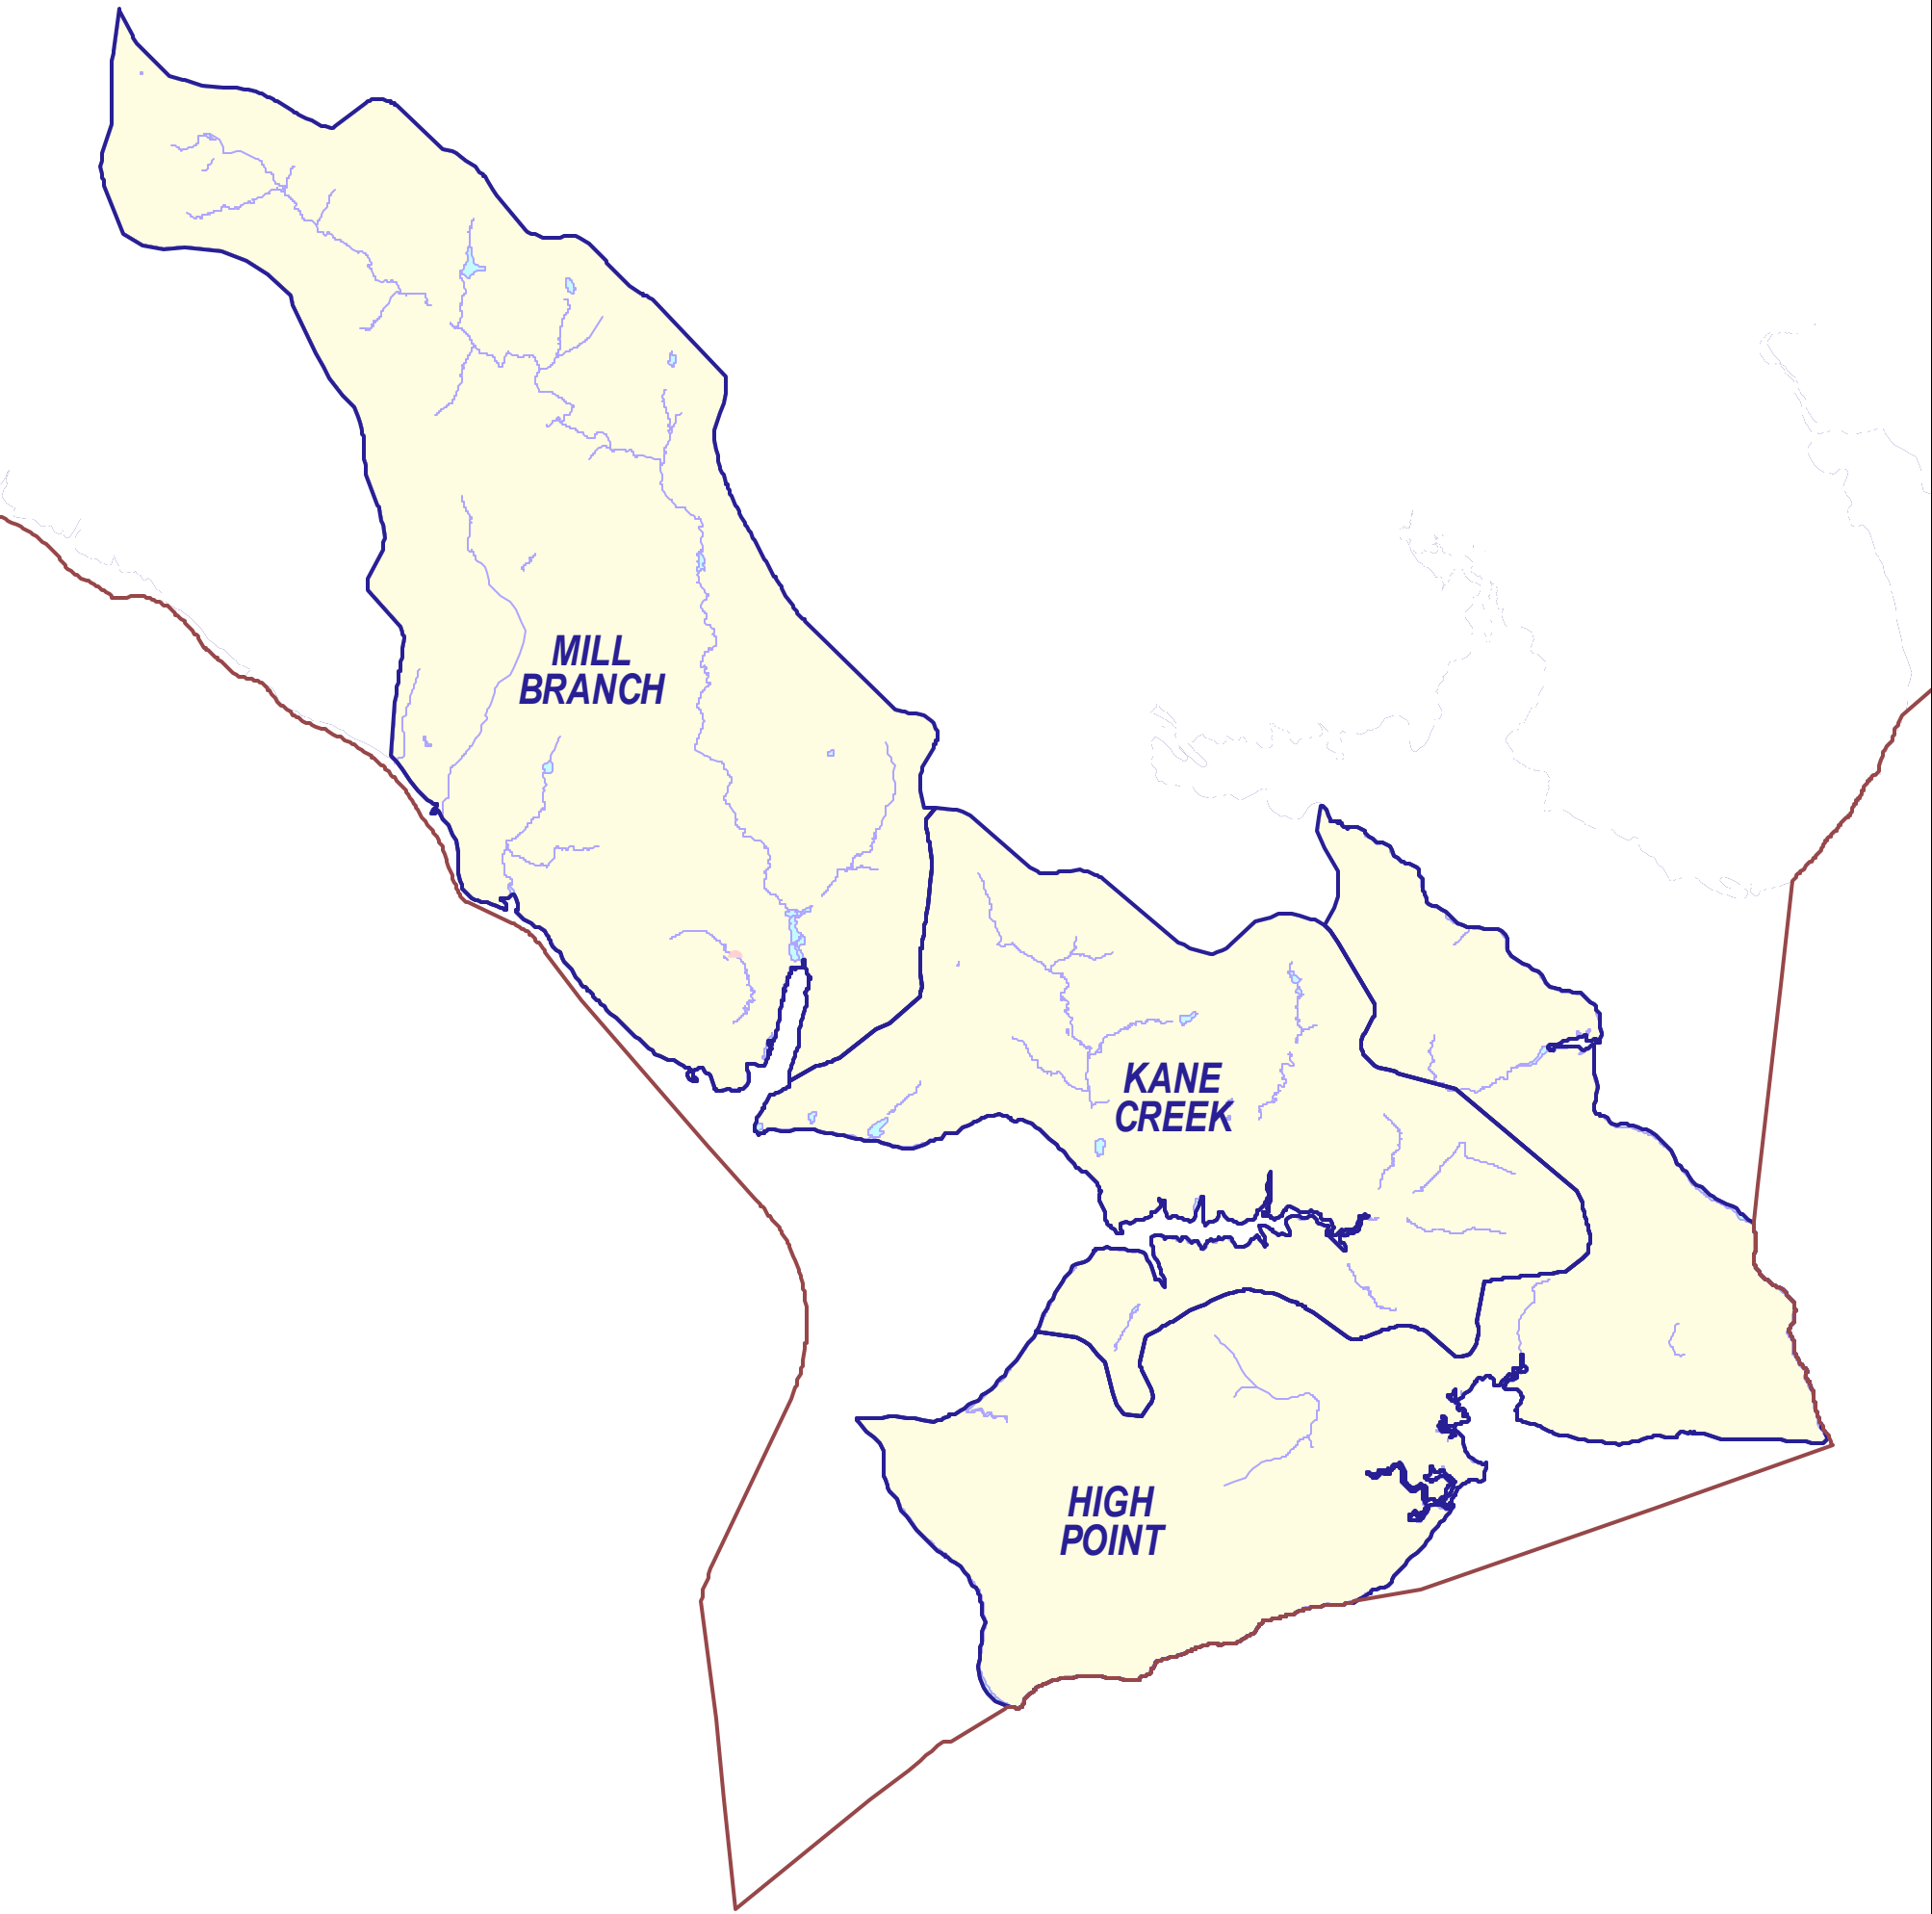
Figure 3-82
Erosion Impacts
Lower Occoquan Group
Fairfax County Stream Physical Assessment

Infrastructure. The infrastructure inventory resulted in 98 inventory points. The most significant problems were related to a utility line, which was given an impact score of 20, and a head cut which was given a score of 10. The infrastructure inventory results are summarized in Table 3-60. Figures 3-82, 3-83, 3-84, 3-85, and 3-86 summarize impact scores for the erosion problems; deficient buffers; crossings; pipes/ditches; and dumps, obstructions, and utilities, respectively.

Infrastructure. The infrastructure inventory resulted in 13 inventory points. The most significant problem was related to a crossing, which was given an impact score of 5. The infrastructure inventory results are summarized in Table 3-62. Figures 3-82, 3-83, 3-84, 3-85, and 3-86 summarize impact scores for the erosion problems; deficient buffers; crossings; pipes/ditches; and dumps, obstructions, and utilities, respectively.

Infrastructure. The infrastructure inventory resulted in 6 inventory points. The most significant problems were related to two deficient buffers, which were given impact scores of 5. The infrastructure inventory results are summarized in Table 3-64. Figures 3-82, 3-83, 3-84, 3-85, and 3-86 summarize impact scores for the erosion problems; deficient buffers; crossings; pipes/ditches; and dumps, obstructions, and utilities, respectively.
